Hilcorp Alaska, LLC

Re: Middle Ground Shoal Platform, Natural Gas Pipeline Release
Middle Ground Shoal Gas Leak Sampling and Monitoring Plan Summary Report
Sampling Period #6 ending 04/25/2017

Weekly Report #6

Prepared by SLR International Corporation (SLR)

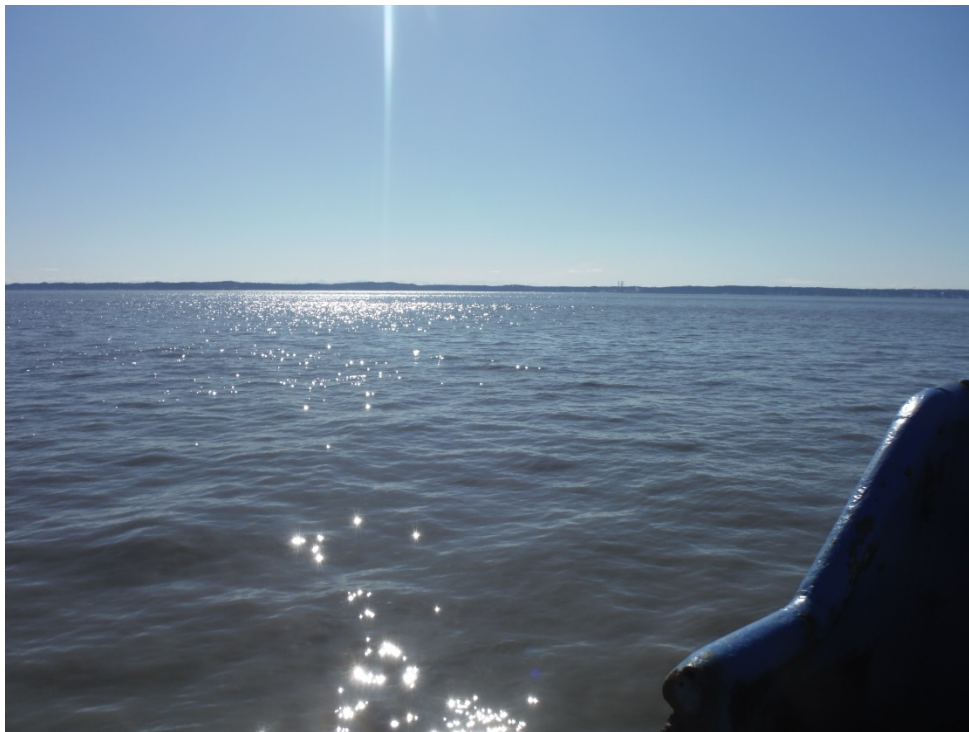
Photo 1: Typical conditions during Week 6, no waves or ice were encountered.

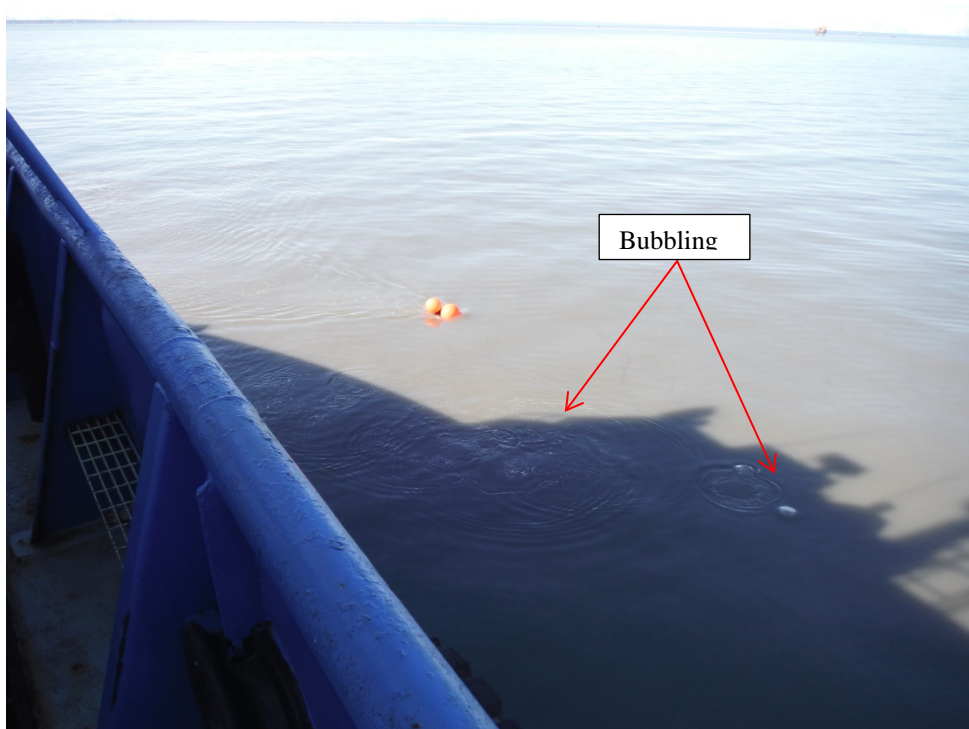
Photo 3:

During slack tide between Drift #1 and Drift #2 the temporary clamp was removed from the leak to install the permanent clamp; the permanent clamp was not completely installed (tightened) prior to Drift #2, and there was some gas leakage. Bubbling was seen on the water surface around the dive buoys placed near the MRP.

Water Quality	Surface 1.5 Mid 6.5 Deep 12	D02-041917	Ebb		3.54	4/19/2017	60 46.944 N 151 25.555 W 60 45.000 N 151 28.091 W		13:05:44	14:16:16	1:10:32	4766	4.2	18.5	0:18:16	Calm	0.2	Temporary clamp was removed during this drift, bubbling observed

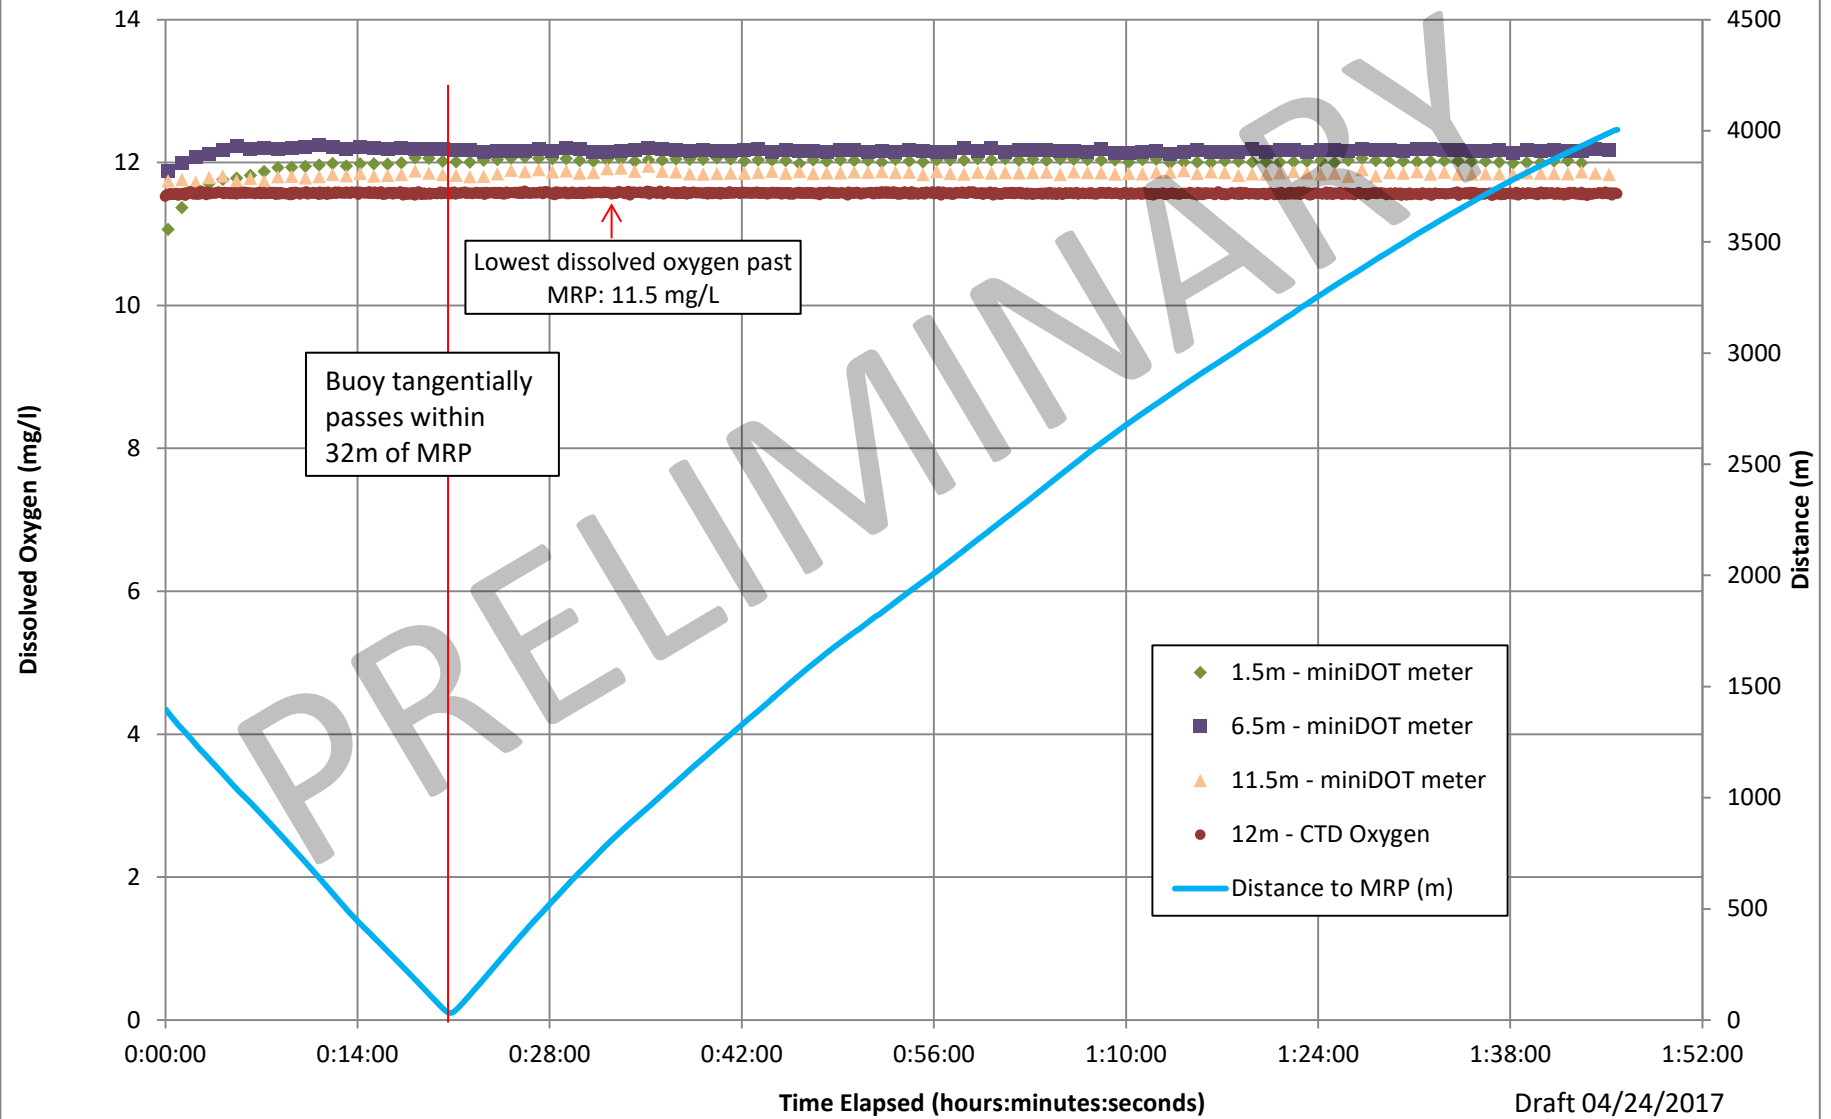
Figure A-9.1a: Buoy Drift #1, April 19, 2017
Dissolved Oxygen Measurements at 1.5, 6.5, 11.5 and 12 Meters Depth
Flood Tide

- Dissolved Oxygen- The lowest DO value recorded after the sensor had time to stabilize and passed the MRP was 11.5 mg/L during Drift #1, and 11.4 mg/L during Drift #2. There was no significant drop in DO concentrations recorded by the sensors as they passed the MRP, and measurements from each sensor were relatively stable throughout the drift (Attachment A, Figures A-9.1a and A-8.2a). During Drift #2 the vessel made a slight course adjustment about 22 minutes into the drift, which caused the instrument string to be dragged upward in the water column with the increased current. This activity coincided with a slight (+/- 0.1) fluctuation in the DO values.

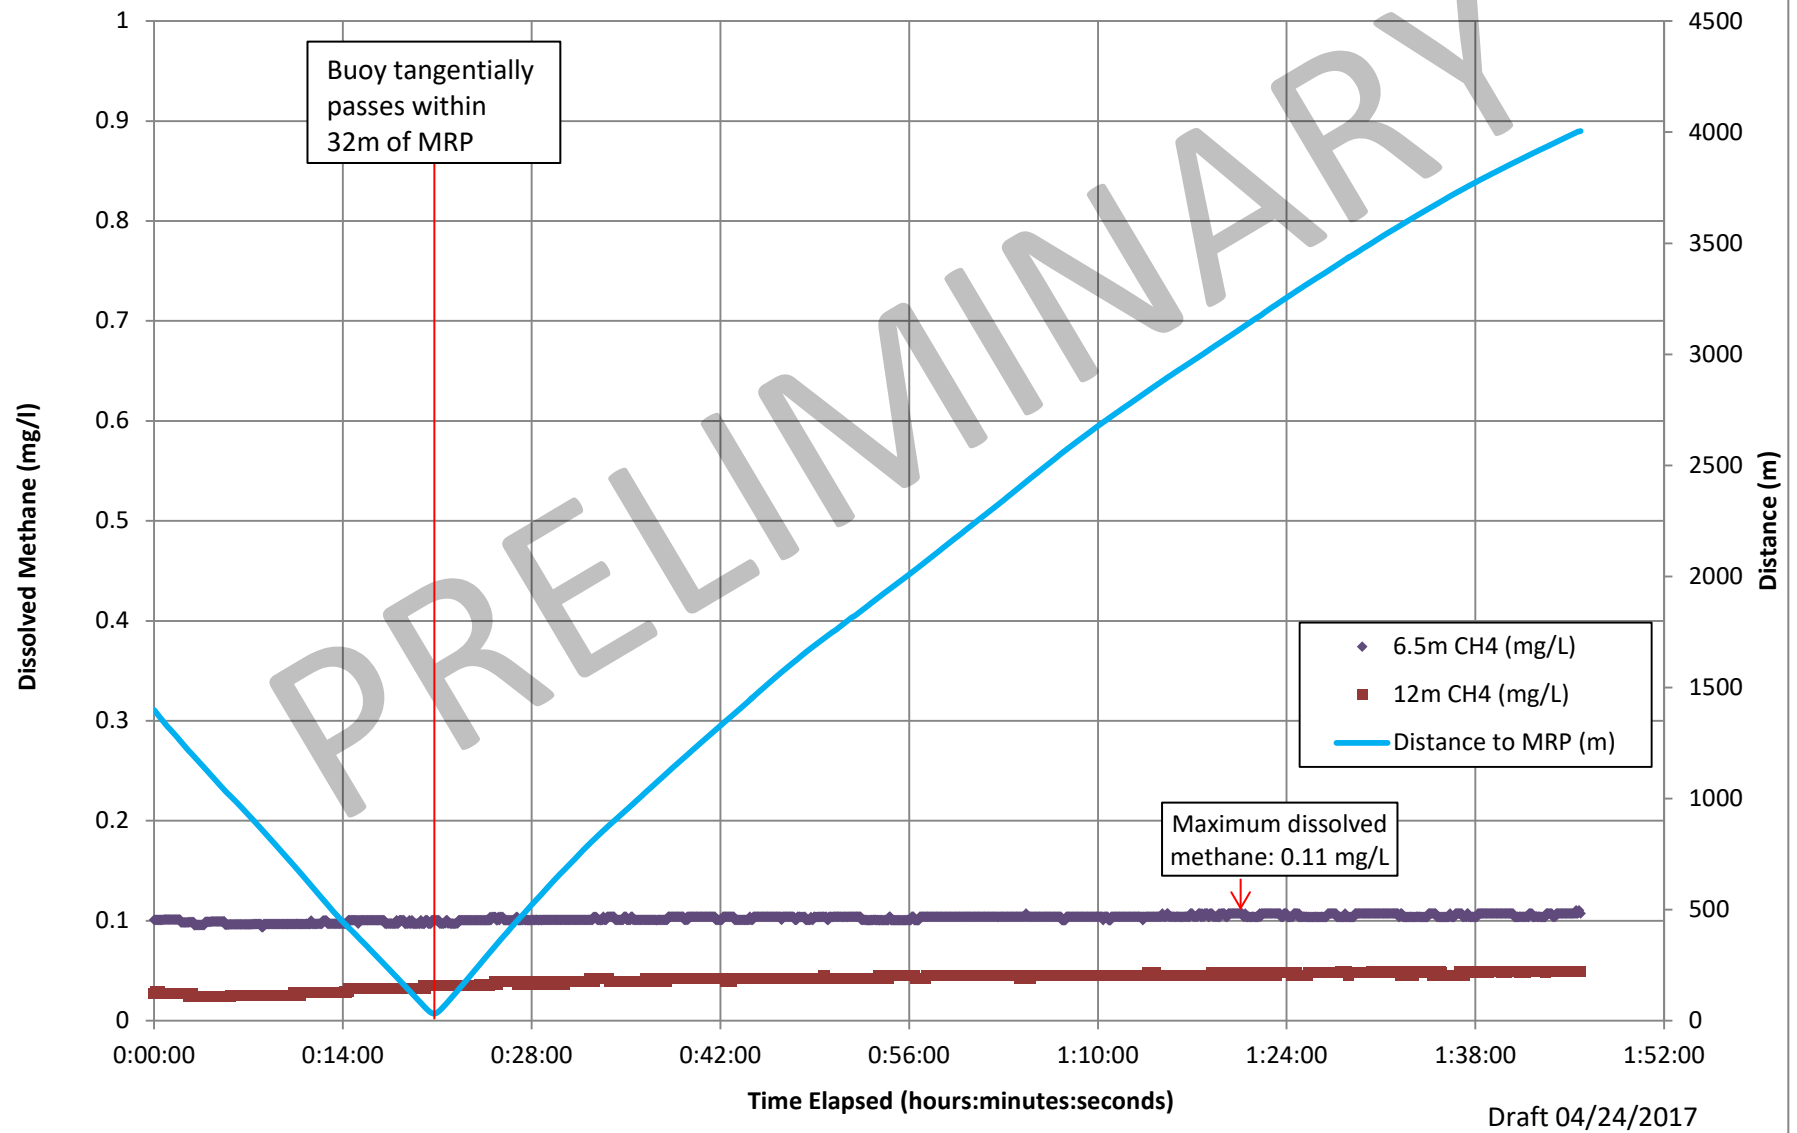
Figure A-9.1b: Buoy Drift #1, April 19, 2017
Dissolved Methane Measurements at 6.5 and 12 Meters Depth
Flood Tide

- Dissolved Methane: The maximum CH₄ concentration recorded was 0.11 mg/L at the 6.5 meter depth during both drifts. The sensor at 12 meters recorded values about 0.05 mg/L less than the sensor at 6.5 meters which has been a typical pattern observed during the monitoring events. The recorded CH₄ concentrations did not show a noticeable (sharp) increase as the sensors passed the MRP, and were relatively stable and consistent throughout the two drifts (Attachment A, Figure A-9.1b and A-9.2b). Overall, the recorded CH₄ concentrations were in the lower range of concentrations measured to date during the project, and similar to the previous week.

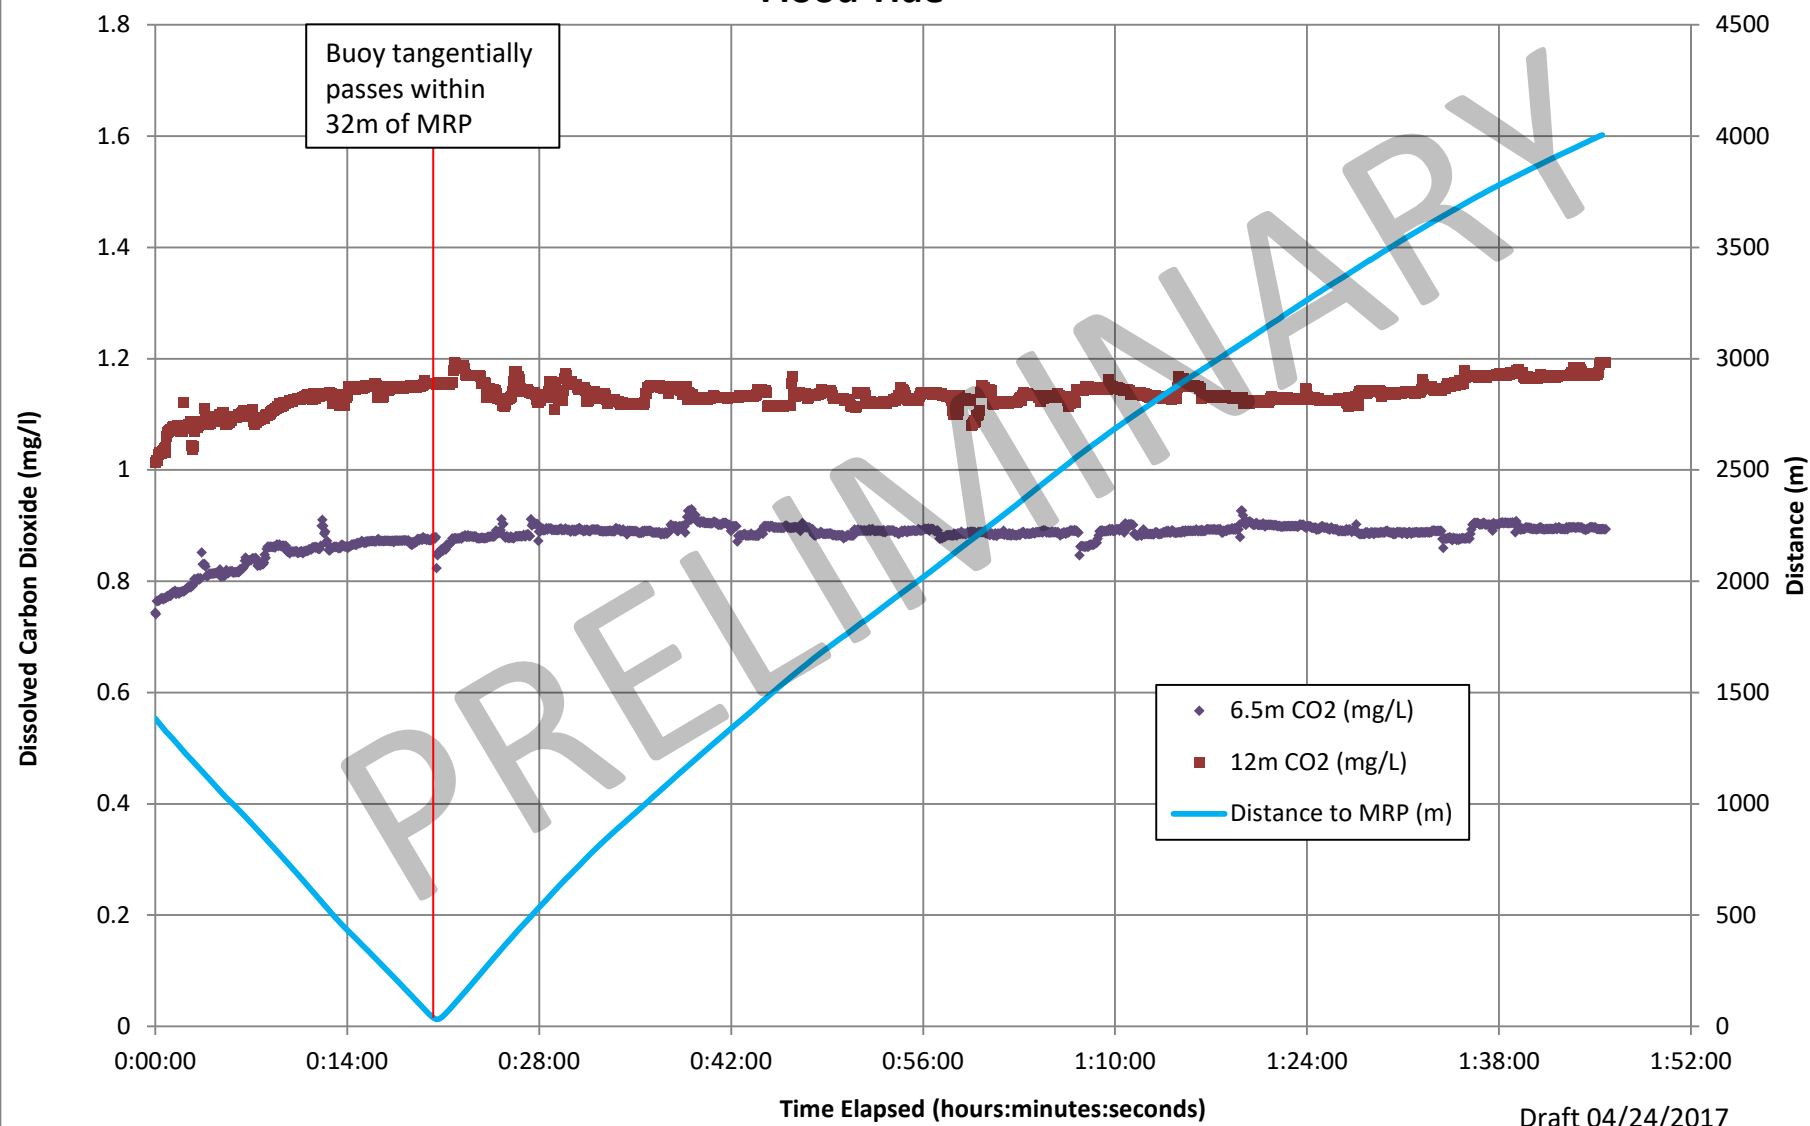
Figure A-9.1c: Buoy Drift #1, April 19, 2017
Dissolved Carbon Dioxide Measurements at 6.5 and 12 Meters Depth
Flood Tide

- Dissolved Carbon Dioxide - CO₂ concentrations recorded during Drifts #1 and #2 did not show any sharp upward fluctuation as the buoy passed the MRP (Figure A-9.1c and Figure A-9.2c in Attachment A). The recorded concentrations varied the most during the initial 10 minutes of each drift and prior to passing the MRP, presumably as the instrument equilibrated with the water conditions. Except for a few outliers, the measured concentrations were between 0.8 and 1.2 mg/L which is consistent with the values recorded each week during the project.
